Manhole Inspection Summary

Manhole # S39I__061MH

Insp Date: **7/9/08 11:54 AM**

Location Address: **217 Stiles St**

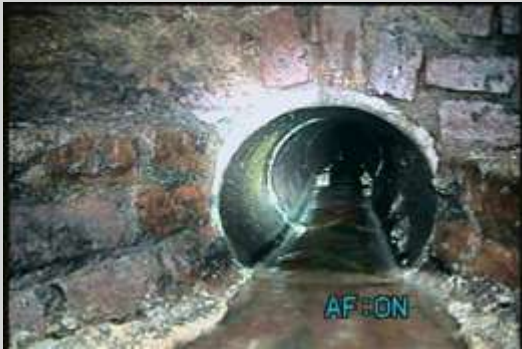
12 O'Clock Outflow

8 in. Circular Gravity Sewer
Pipe Out @ 12 O'Clock

Deposits: ☒ None ☐ Mud ☐ Sludge ☐ Debris ☐ Grease

Infiltration: **None** Pipe Seal Cond: **Unknown**

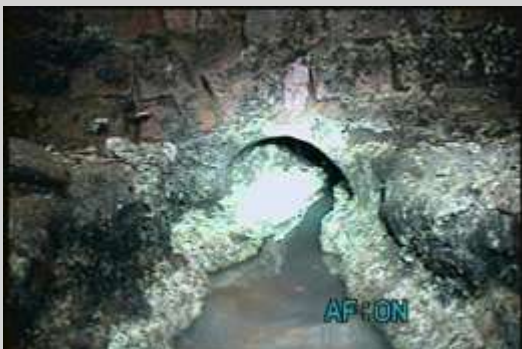
5 O'Clock Inflow

8 in. Circular Gravity Sewer
Pipe In @ 5 O'Clock

Deposits: ☒ None ☐ Mud ☐ Sludge ☐ Debris ☐ Grease

Infiltration: **None** Pipe Seal Cond: **Unknown**

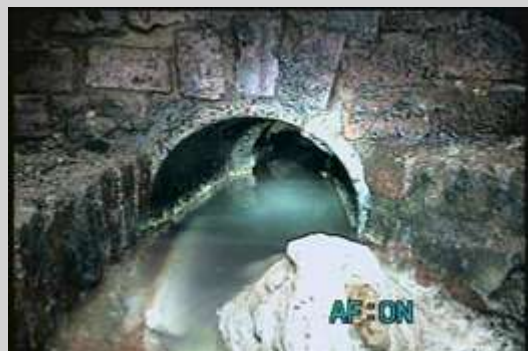
9 O'Clock Inflow

8 in. Circular Gravity Sewer
Pipe In @ 9 O'Clock

Infiltration: **None** Pipe Seal Cond: **Unknown**
